EMERGENCY ACTION PLAN

COWPATH DAM AND SULLIVAN DAM

SHELBY, MONTANA

Prepared by: Kadrmas, Lee & Jackson
1075 N Rodney, Suite 101
Helena, MT 59625-1567

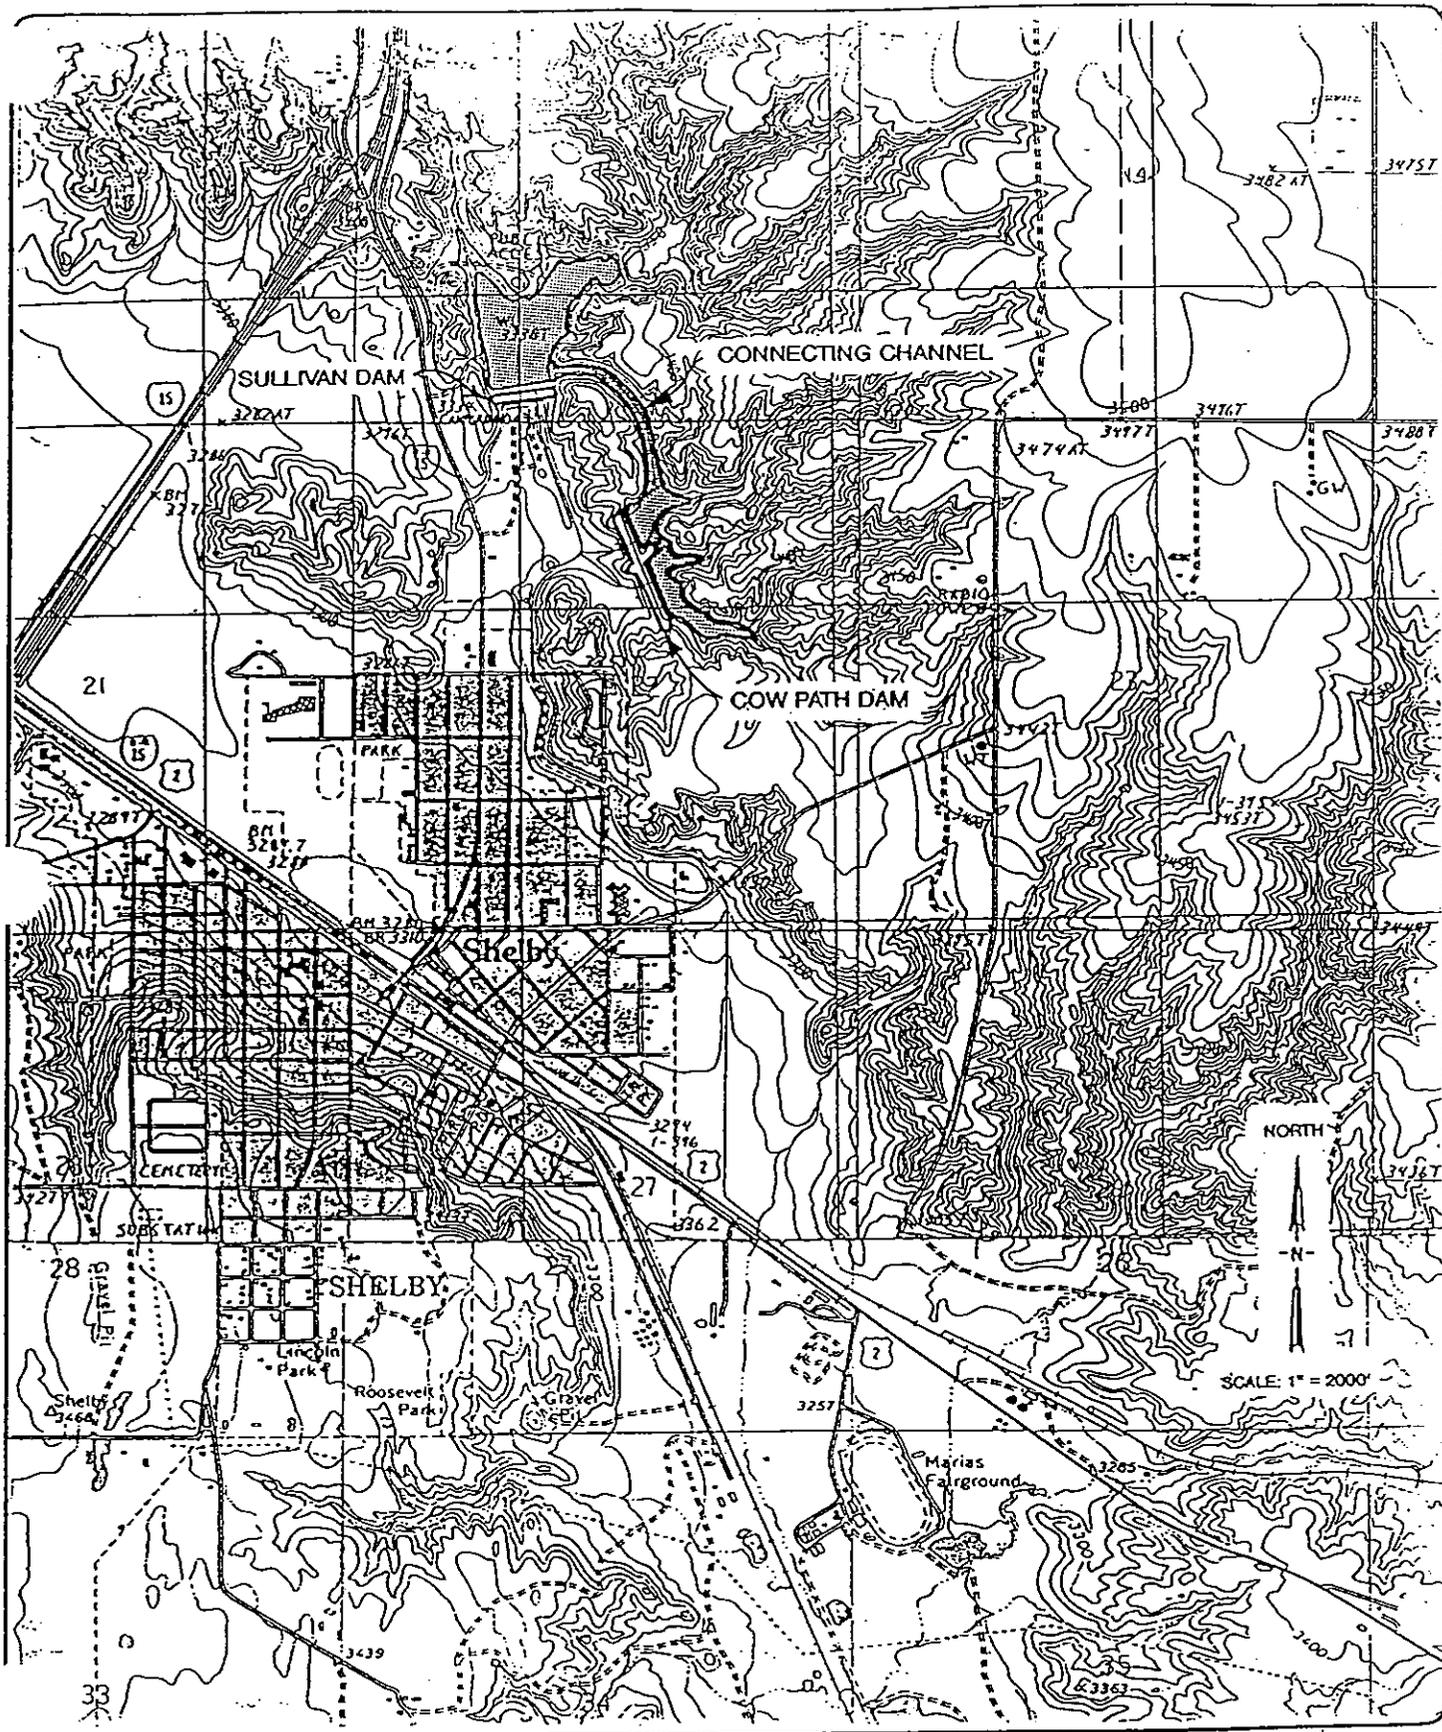
FIGURE 1

**COW PATH AND SULLIVAN DAMS
VICINITY MAP**

The Cowpath Dam/Sullivan Dam facility is located in the south 1/2 of Section 15, and the north 1/2 of Section 22, Township 32 North (T32N), Range 2 West (2W), Toole County, Montana. The dams are located on an unnamed tributary to the Marias River. The facility is owned by the City of Shelby and is used as a flood protection, recreation, and fish and wildlife storage facility. Technical data pertaining to the Cowpath Dam/Sullivan Dam facility are listed in Appendix A. The locations of the dams are shown on Figure 1.

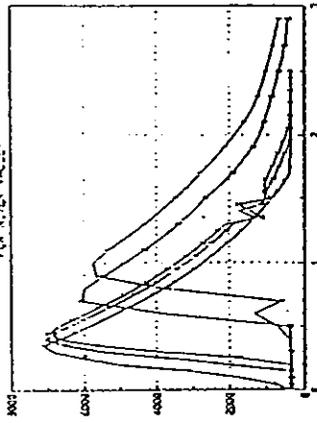
COMBINED FLOW HYDROGRAPHS
FOR UPPER VALLEY

STAGE HYDROGRAPH (CG: 0000 m)
MAX. STAGE 5396 ft. AT 3300-hr. GAGE ZERO 3314.220 ft.

Clear-weather
breach
hydrographs

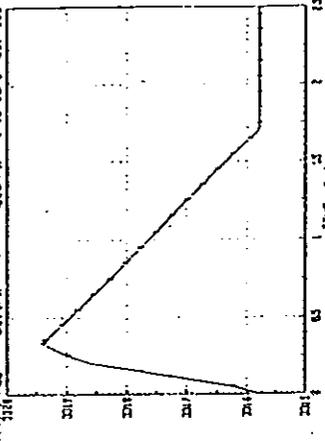
STAGE HYDROGRAPH (CG: 550 m)
MAX. STAGE 3379 ft. AT 1480-hr. GAGE ZERO 3300.220 ft.

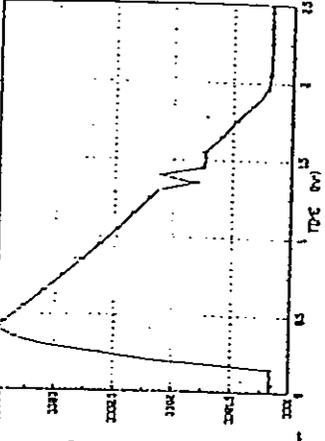
STAGE HYDROGRAPH (CG: 550 m)
MAX. STAGE 3379 ft. AT 1480-hr. GAGE ZERO 3300.220 ft.

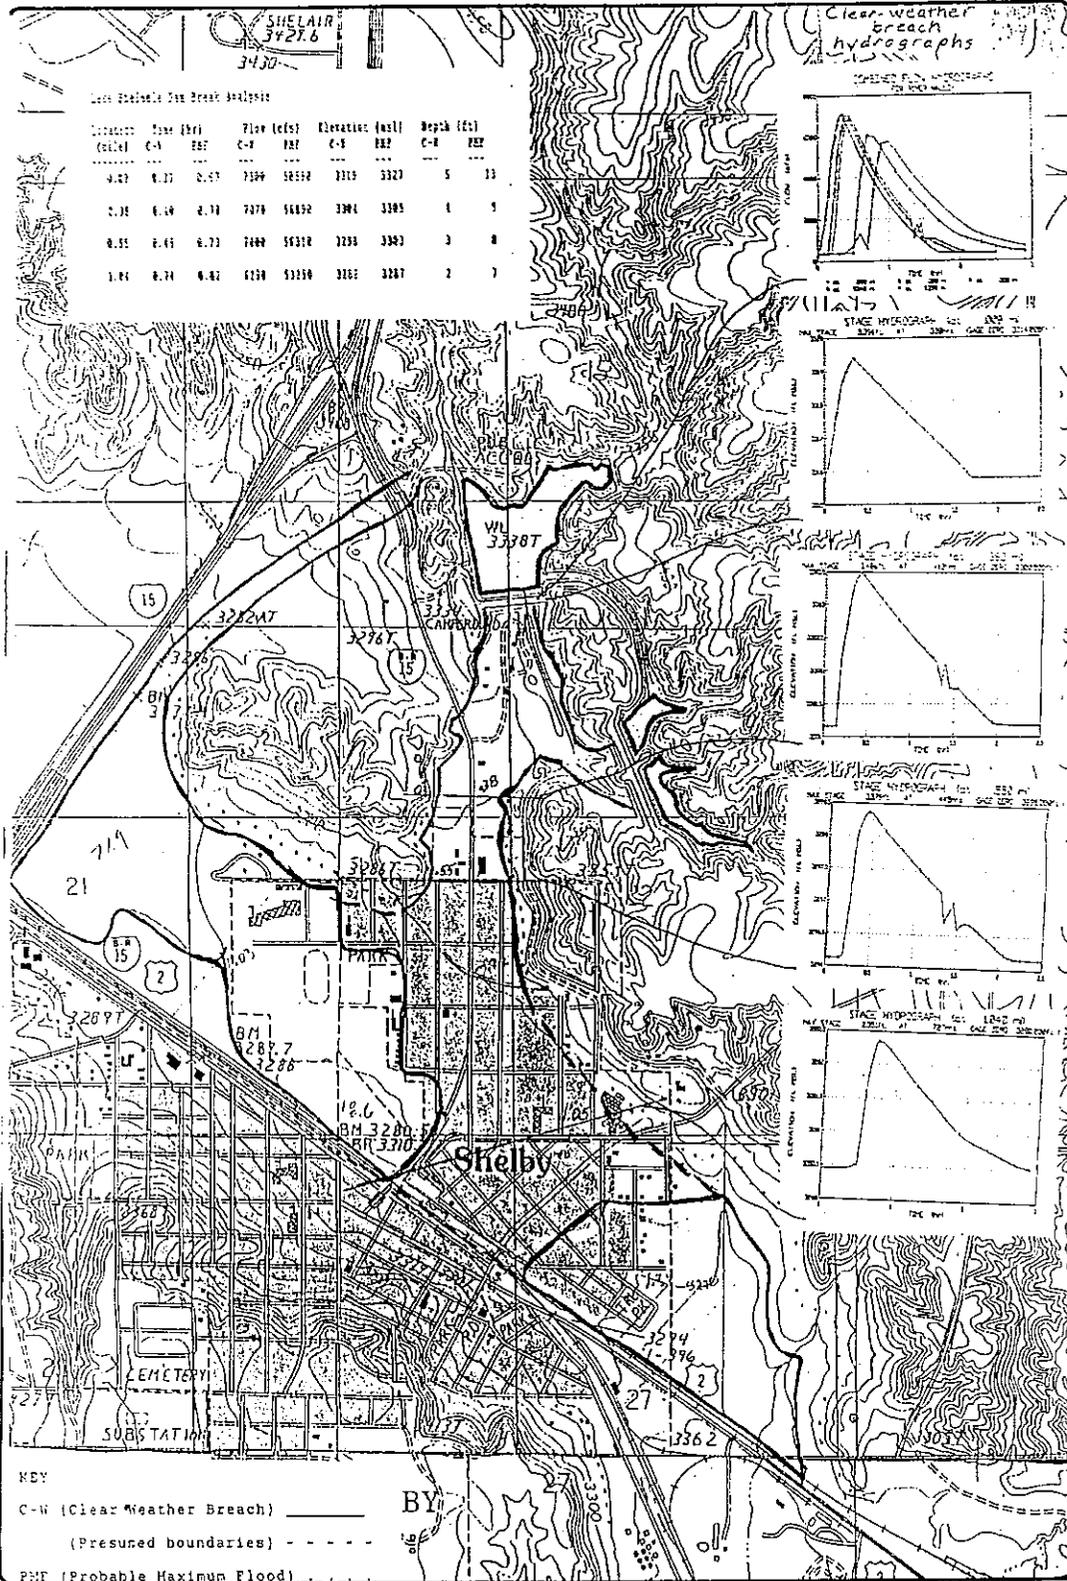
APPENDIX B
HKA ASSOCIATES
 ENGINEERS • PLANNERS
 8M334.101 | NOV 91

COW PATH AND SULLIVAN DAMS
 INUNDATION AND EVACUATION MAP

The evacuation area extends through the City of Shelby and along the unnamed tributary to the confluence with the Marias River approximately seven miles to the south, as shown in Appendix B. Hazards include the possible inundation of commercial and residential buildings, the railroad and State Highway 2. Inundation and evacuation maps are included in Appendix B.
